**CANOE BROOK RESERVOIR  
NO. 3 DAM**

**CANOE BROOK RESERVOIR  
NO. 3 DIKE**

**3 PHASE I INSPECTION REPORT  
NATIONAL DAM SAFETY PROGRAM.**

PHASE I REPORT  
NATIONAL DAM SAFETY PROGRAM

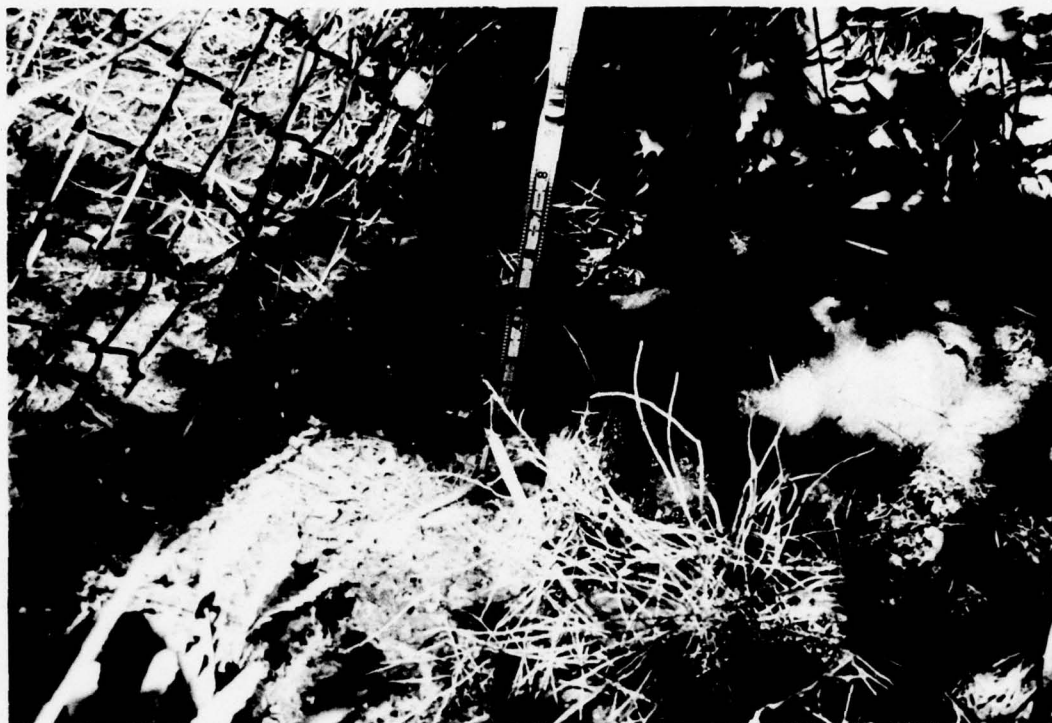
**PHOTO 2**

- Photo 2 - Close-up of Seepage and Sand Boil Area at Approximately El. 190 on Right Side of Downstream Slope of Dam (Center of Overall View of Dam); Pencil at Boil in Silty Sand - 14 June 1978.

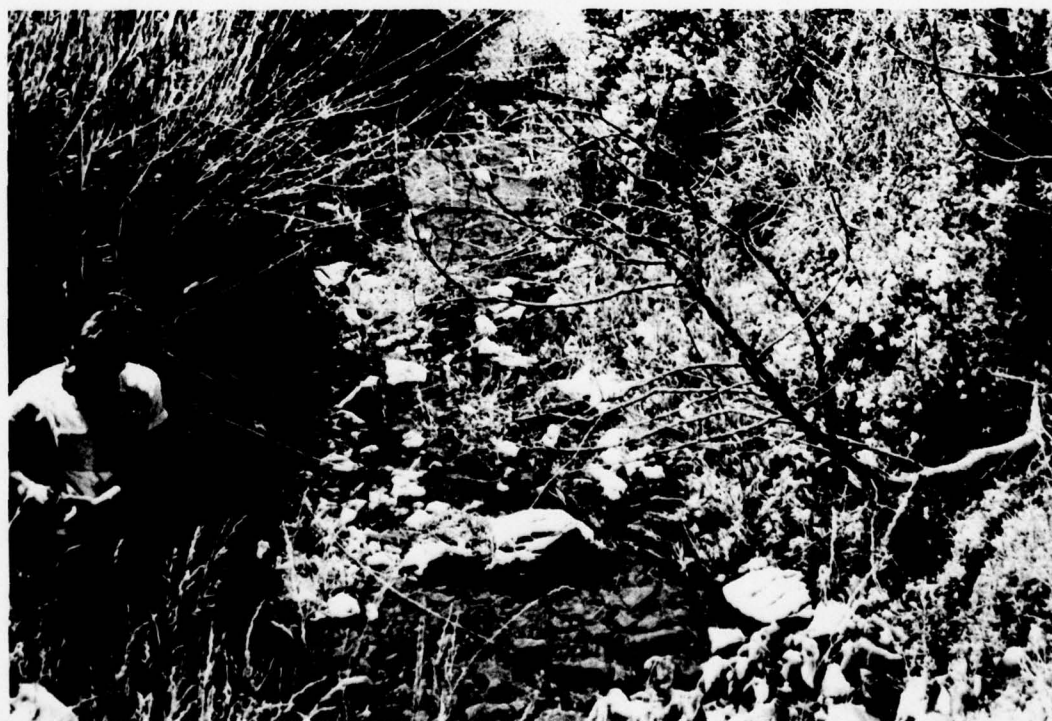
**PHOTO 3**

- Photo 3 - Close-up of Eight Inch Toe Drain Outlet Partially Plugged with Sediment and Debris, Downstream Toe of Dam About 40 Feet Northeast of Headwall Shown in Photo 1 - 14 June 1978.

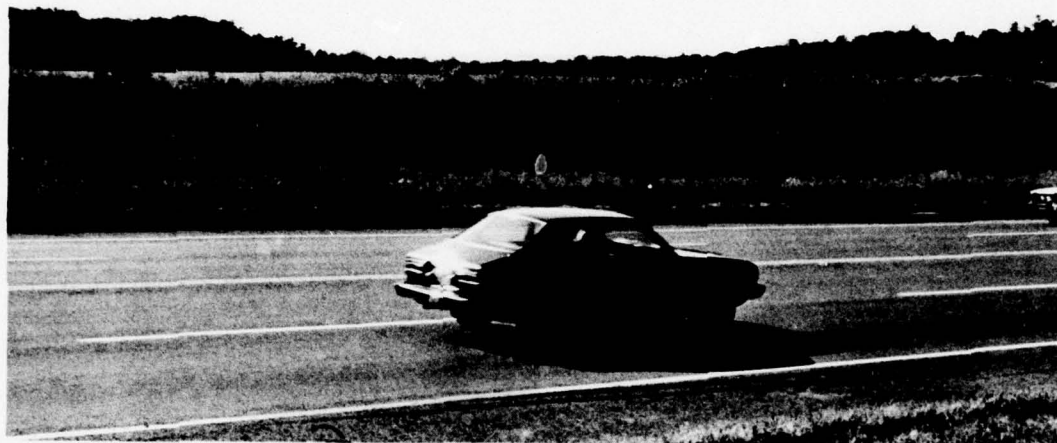
**PHOTO 4**

- Photo 4 - View Downstream from Top of Headwall Shown in Photo 1 - 14 June 1978.
- Photo 5 - View Northwest Across Eisenhower Parkway at Maximum Height Dike Section; Curb Inlet Between Two Cars Marks Inlet of 36 Inch Storm Drain Extending Beneath Reservoir to Outlet Shown in Overall View of Dam; Crest of Dam is in Center of Photo, Above Dike Crest and Below Tree Line - 14 June 1978.
